**2013 Operations, Maintenance, and  
Monitoring Report**

**Holly Beach Sand Management**

State Project Number CS-31  
Priority Project List 11

June 2013  
Cameron Parish

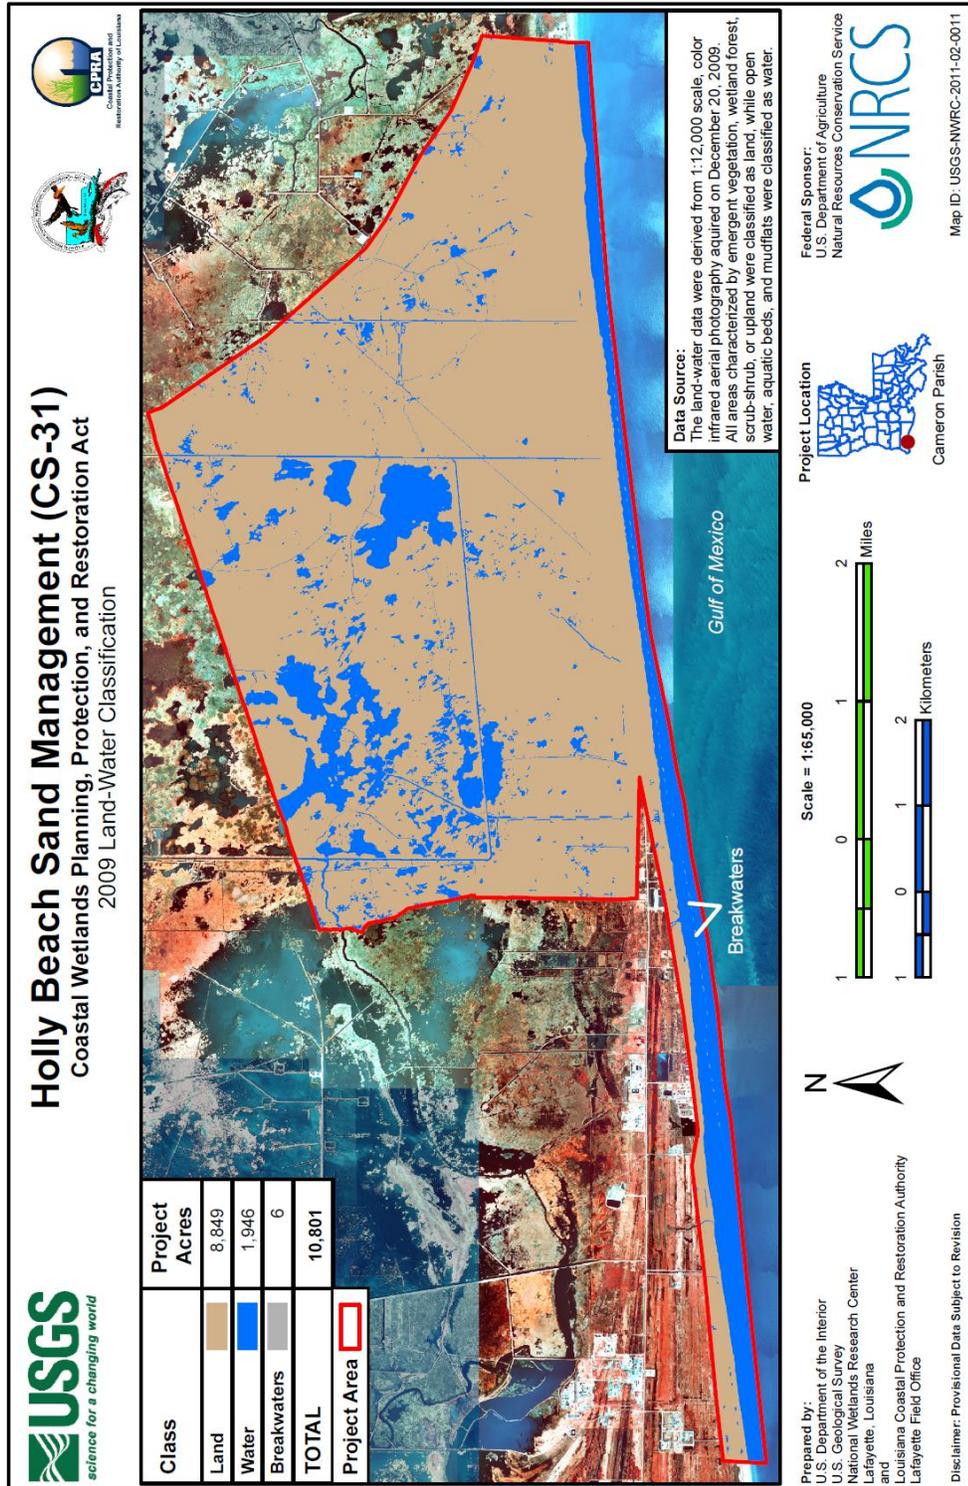
Land to water analysis was completed for the pre-construction photography acquired in November 2001 and December 2002 and post-construction acquired in October 2005 and December 2009 (figures 2 - 6). Results are presented in Table 1. The difference between the 2001 and 2002 analyses was due to the partial construction of the beach at the time of the 2002 photography. The 2005 analysis followed Hurricane Rita and showed approximately 40 acres of land lost, mostly along the shoreline. The 2009 analysis, which would have covered the period of Hurricane Ike, showed another 48 acres lost since the 2005 analysis.

**Figure 6.** Land/Water analysis of the Holly Beach Sand Management (CS-31) project area from photography obtained December 20, 2009.

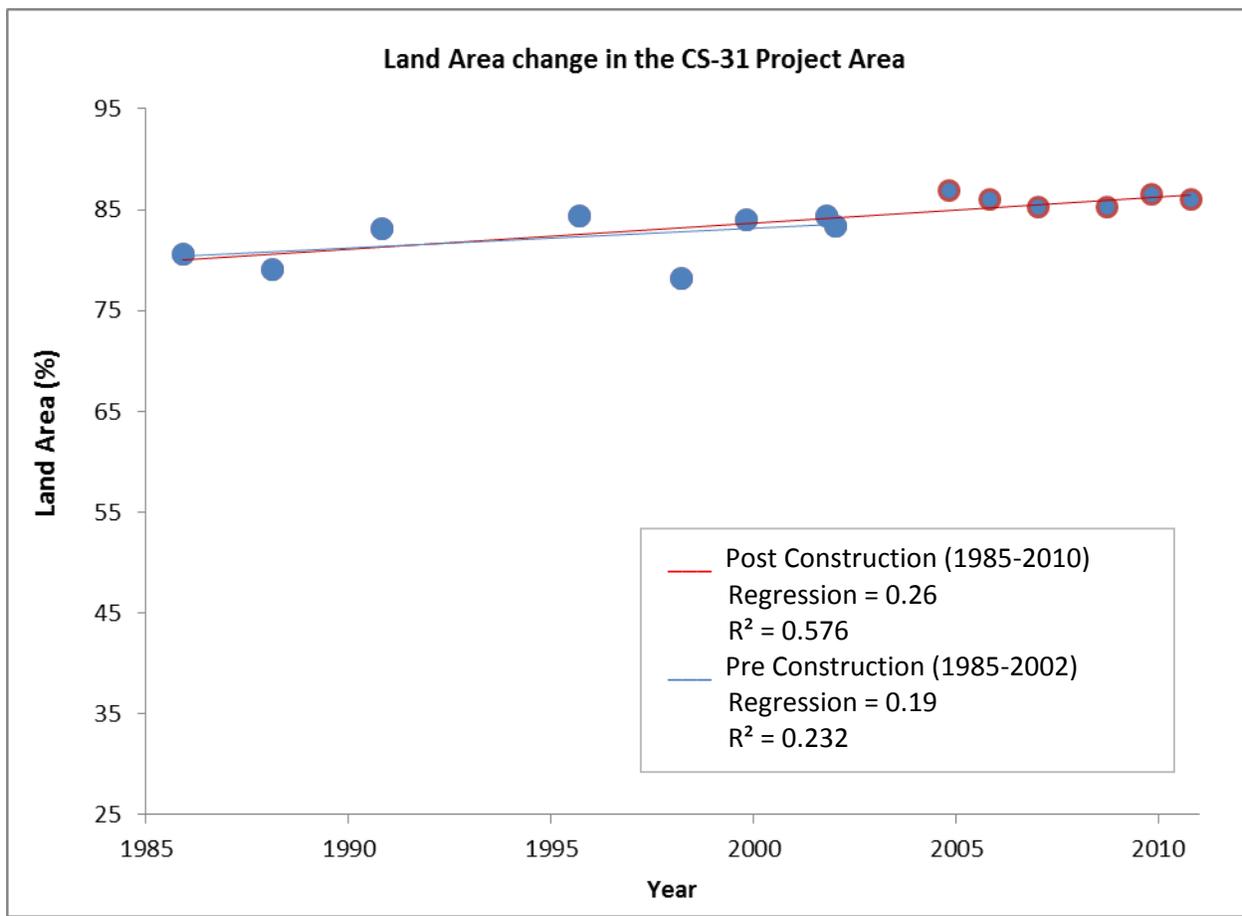
The general land change trend within the project area prior to construction was slightly positive (0.19% per year) from 1985 – 2002 (figure 7). Incorporating the 2002 to 2010 data, which includes the post-construction satellite imagery, causes the general trend to increase slightly (0.26% per year), even though the project area saw land loss following the hurricanes.

**Figure 7.** Project scale percent land change for CS-31. Percent land values are displayed for all cloud free TM images available for 1985-2010. The red line depicts the percent land trend for the entire period of record. The blue line depicts the percent land trend for the pre-construction time period only. Percent land calculated as percent land of total project area. See Couvillion et al. 2011.

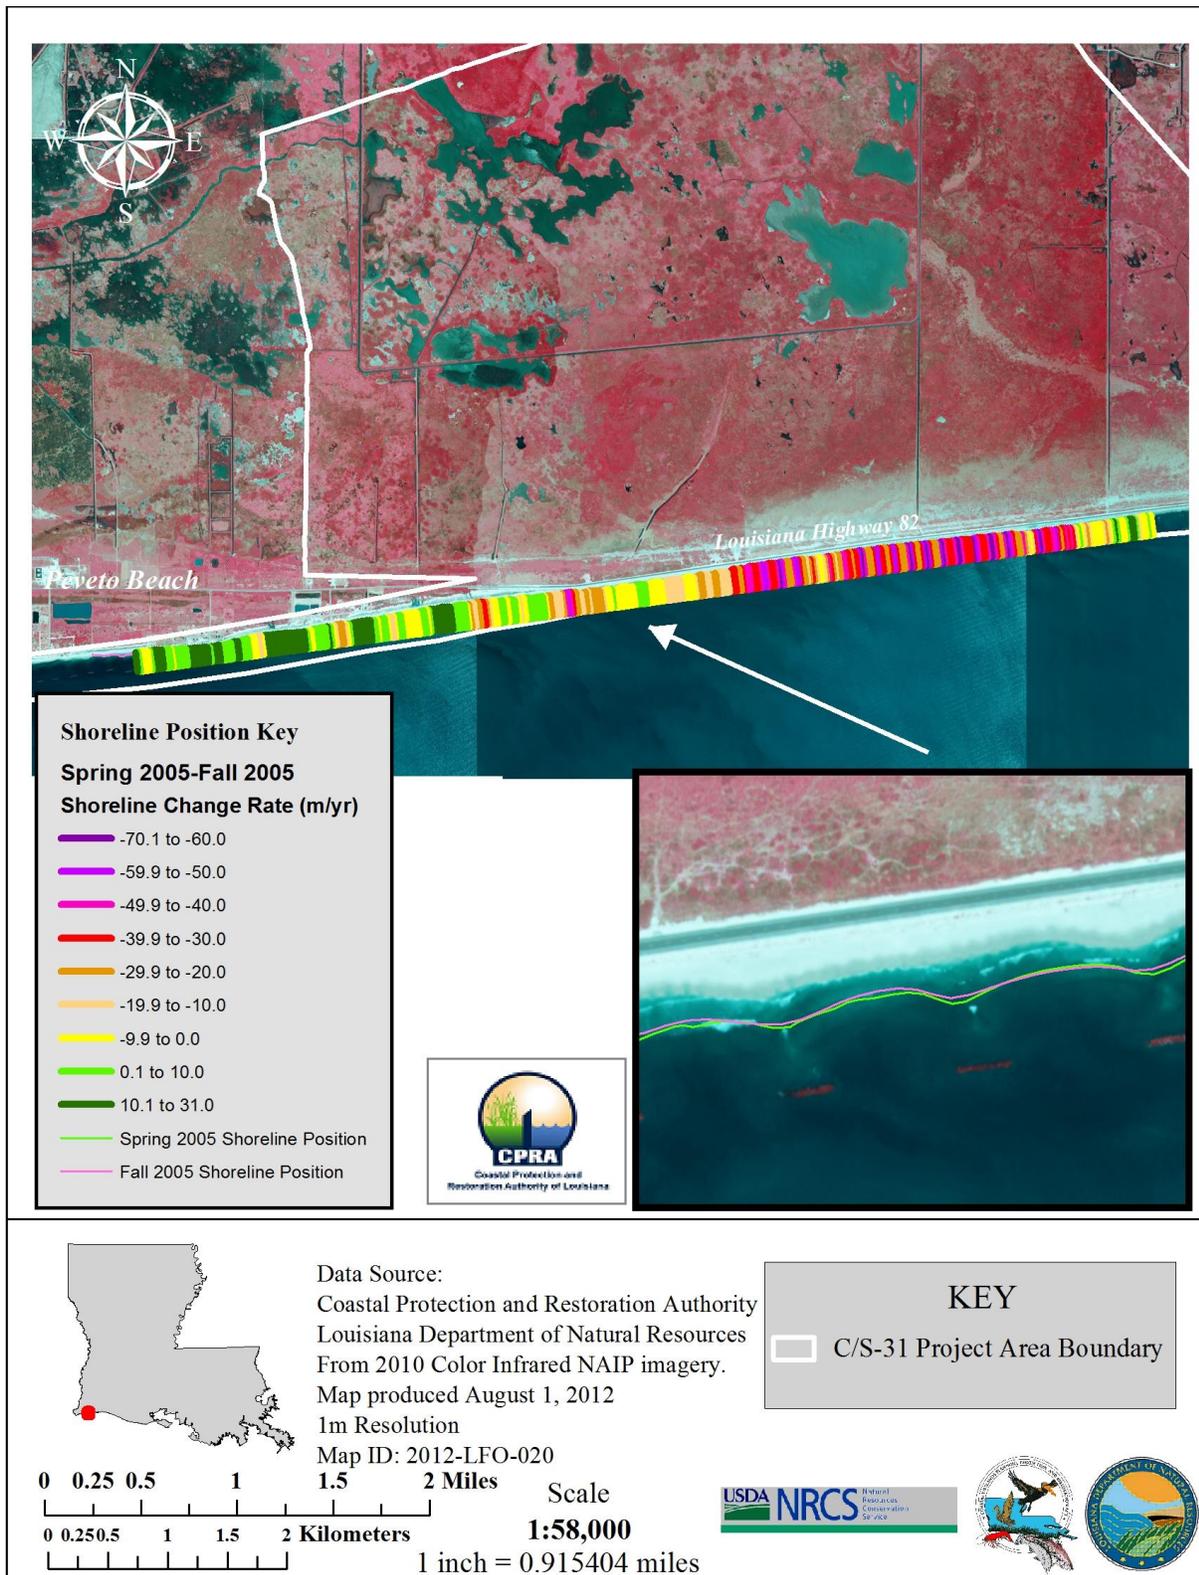
The data indicate an average loss of -6.12 ft/yr between the spring 2003 and spring 2004 surveys (table 3). This period would be considered the initial adjustment period after construction when the beach was taking shape. The beach was expected to quickly degrade during this time period due to an overfill of sand by the contractors. The pre-Hurricane Rita data (spring 2003 to spring 2005) indicate an average loss rate of -17.72 ft/yr. The post-hurricane Rita survey (comparing spring 2005 to fall 2005) showed an average of -46.33 ft/yr was lost during the storm (figure 12). Comparing the fall 2005 to spring 2006, which would be considered the recovery period after the impact, indicated an average loss rate of -41.47 ft/yr. The post-hurricane Ike survey (comparing spring 2007 – fall 2009) showed an average of -5.27 ft/yr was lost during the storm (figure 13). The post-Hurricane Ike recovery period (comparing fall 2009 to spring 2011) showed an average loss of -15.52 ft/yr. The final survey (comparing spring 2011 to fall 2011) showed a gain of +8.79 ft/yr. Average loss across all surveys (spring 2003 to fall 2011) was -8.76 ft/yr (figure 11). These should not be taken individually as an actual indication of loss rates along the beach, but rather an indication of the processes occurring along the beach. Unlike the bathymetric/topographic surveys, these shoreline surveys can be influenced by tide levels considering the gentle slope of the beach (1:40 during construction) and the fact that elevation is not taken into account during data collection. For instance, tide levels were 1.66 ft higher during the spring 2006 survey compared to the fall 2005 survey which may have exaggerated loss rates. Tide levels during the surveys are presented in Table 3. Loss rates appeared to be fairly uniform across the project area in most surveys prior to Hurricane Rita. However, the post-Hurricane Rita and post-Hurricane Ike data indicate greater loss rates along the eastern side of the beach and some gain along the western end (figure 12). The hurricanes appear to have shifted large amounts of sand to the western side.

**Figure 12.** Shoreline change rates comparing pre- and post- Hurricane Rita surveys.

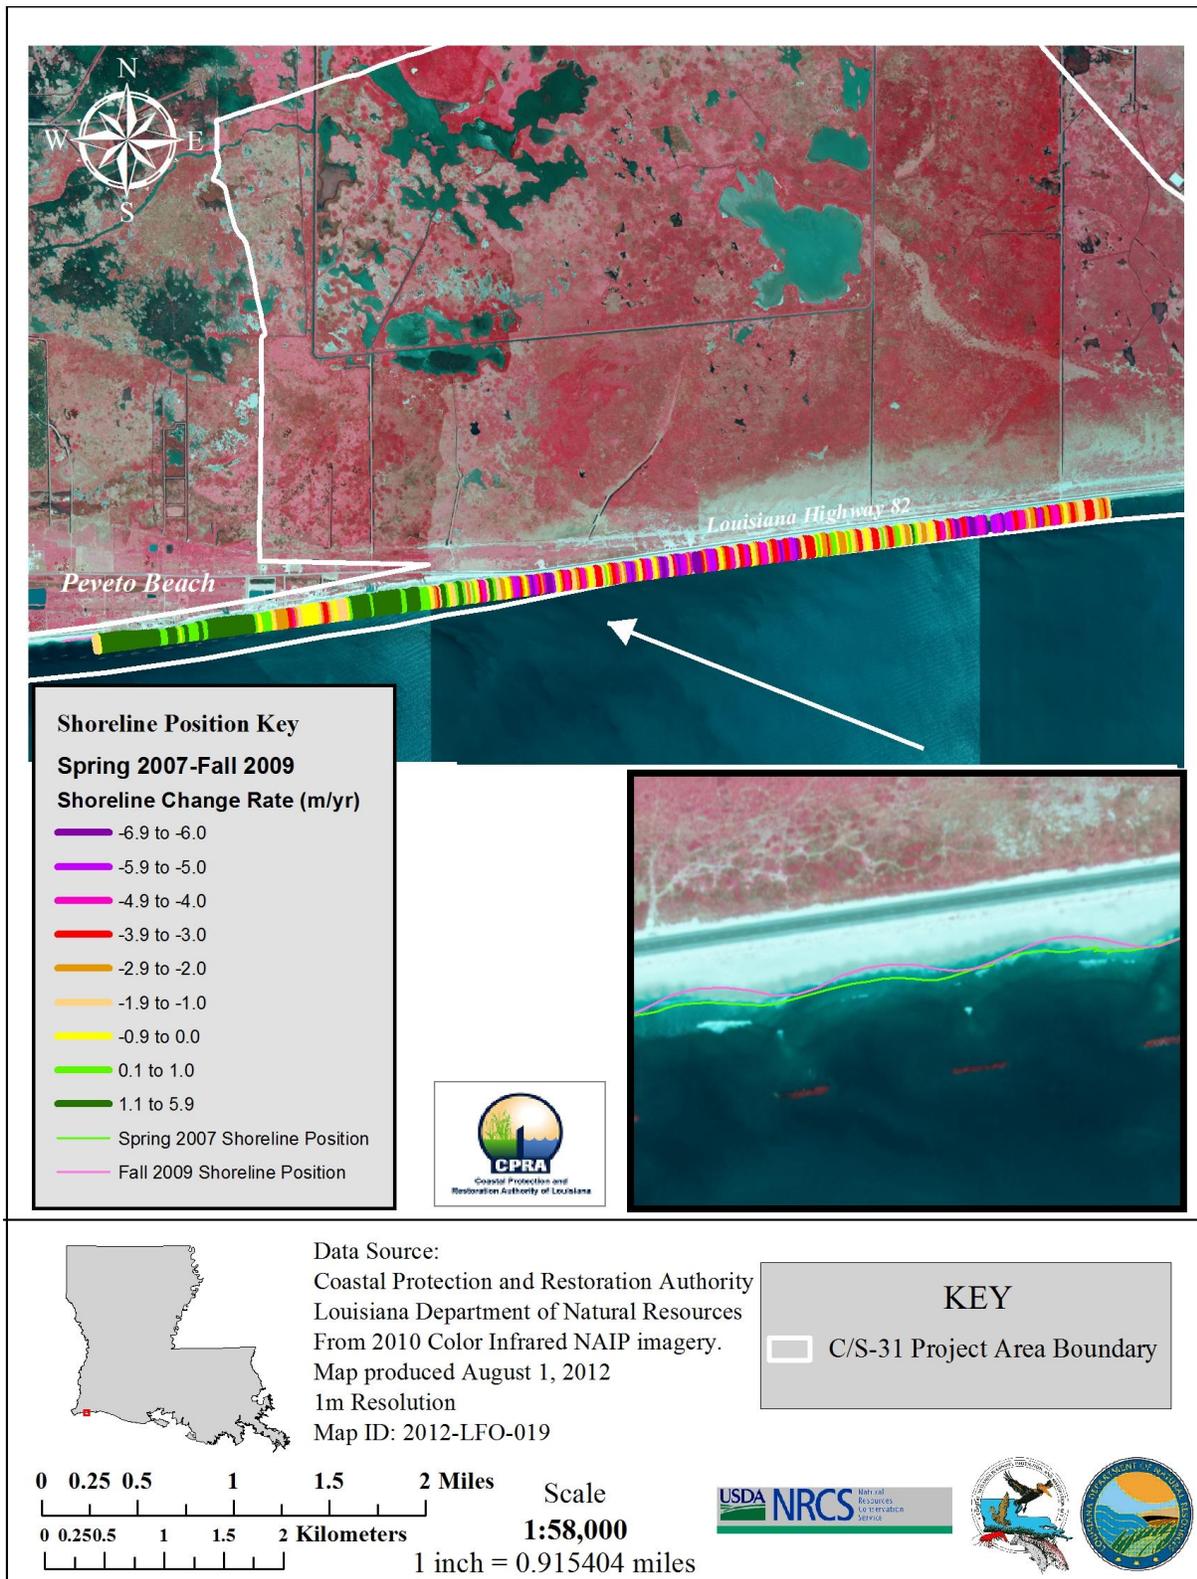
straight line north of the beach, running parallel to the beach (for breakwaters 10 thru 72). Transects were placed perpendicular to the baseline, spaced 20 m apart, and measured from the baseline to the shoreline position at the 2.55 ft contour within each survey. Shoreline change was calculated by subtracting the August 2005 shoreline position from the January 2006 shoreline position and then the January 2006 shoreline position from the January 2009 shoreline position. The 2006 data indicate that the shoreline retreated at an average of 21 ft/yr during the time period that included Hurricane Rita. By comparing the 2009 data to the 2006 data, the data indicated that 11 ft/yr was lost during the time period that included Hurricane Ike.

**Figure 13.** Shoreline change rates comparing pre- and post- Hurricane Ike surveys

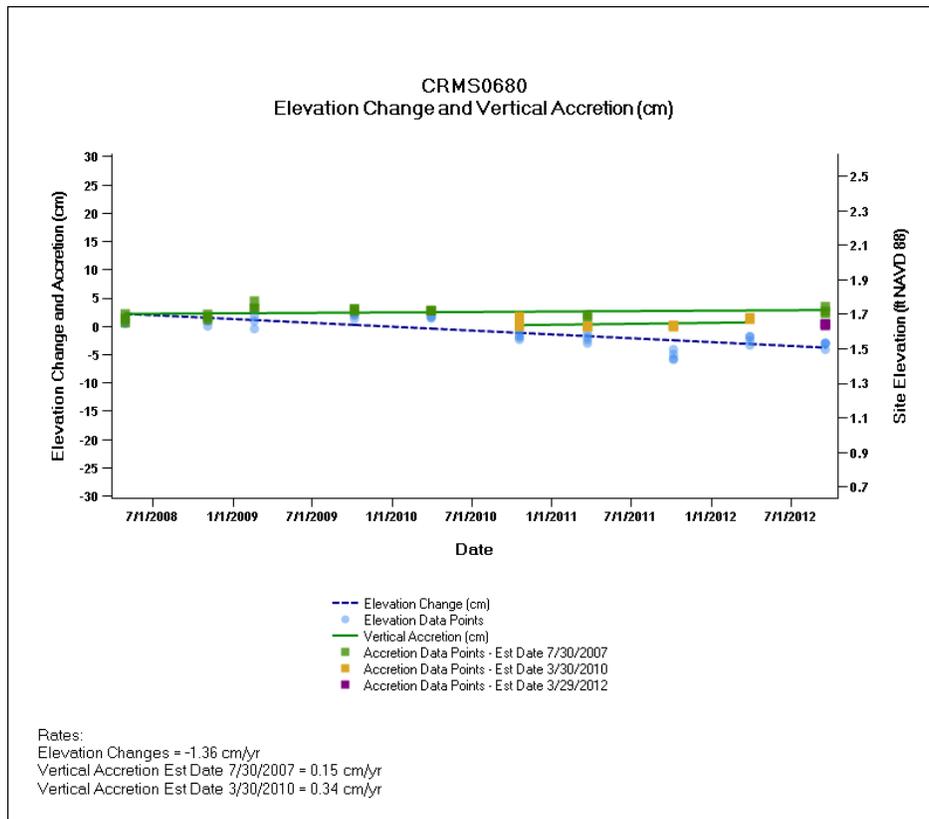
Project station CRMS0680 (Figure 21) showed a negative elevation change of over -1 cm/yr in the 5 years that it has been sampled. The elevation at the site appeared to be increasing prior to 2011. The introduction of cattle to the area likely caused compaction and possibly erosion as a result of the grazing activity. The site had a very low SVI score of 7.48 and given the current trend, would be submerged within 5 years. The SVI score at CRMS0680 was also well below average when compared to other brackish CRMS sites coastwide in 2012. Reference station CRMS2219 has not had enough measurements to calculate viable elevation change rates at this time.

**Figure 21.** Accretion and Elevation change for project station CRMS0680 over 10 samplings for the period July 2007 to September 2012.
